Undoing Past Sins

A long-term surveying project at a mine reclamation job in Maine shows how using multiple satellite positioning constellations can improve productivity.

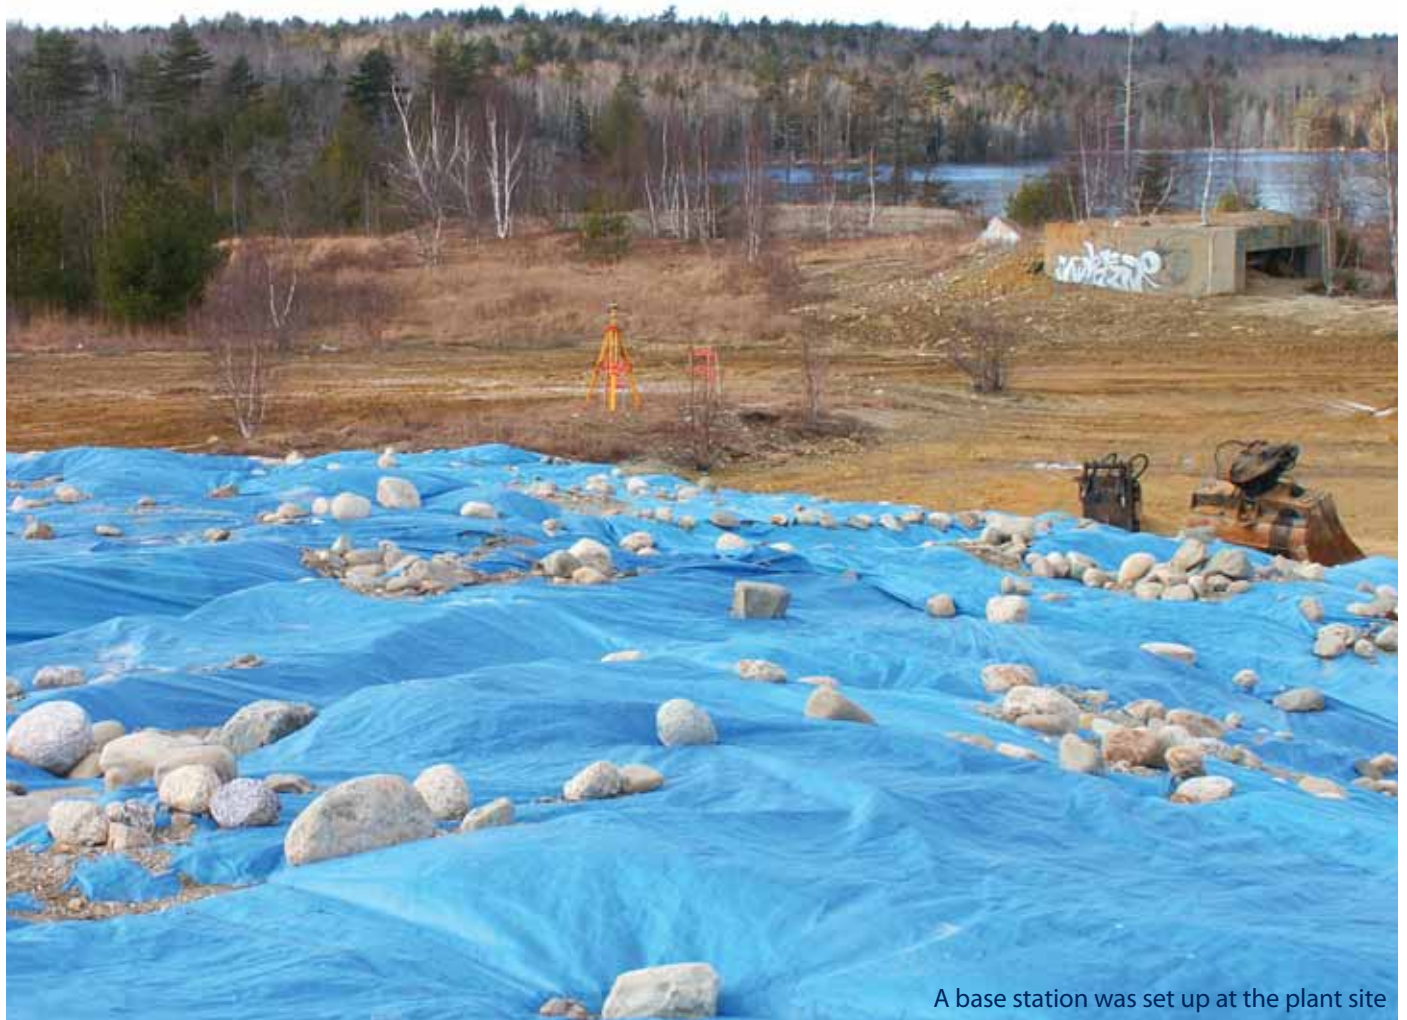
A base station was set up at the plant site

The only unusual aspect of this part of the assignment is the need to keep a detailed log covering everything done over the two-year course of the project. These activities are also complicated by the fact that the site is getting a major facelift, which makes keeping accurate survey control more difficult. "Because the GR-3 base station can be set up virtually anywhere, even a half mile away from

the site,” Salsbury says, “we can extend our control well outside the project limits. We have several convenient control points scattered around the site, so we can quickly set up and get to work. The site is hilly with scattered trees plus trucks and earthmoving equipment to interrupt conventional lines of sight, but with the GR-3 RTK, we don’t need to maintain line of sight.”

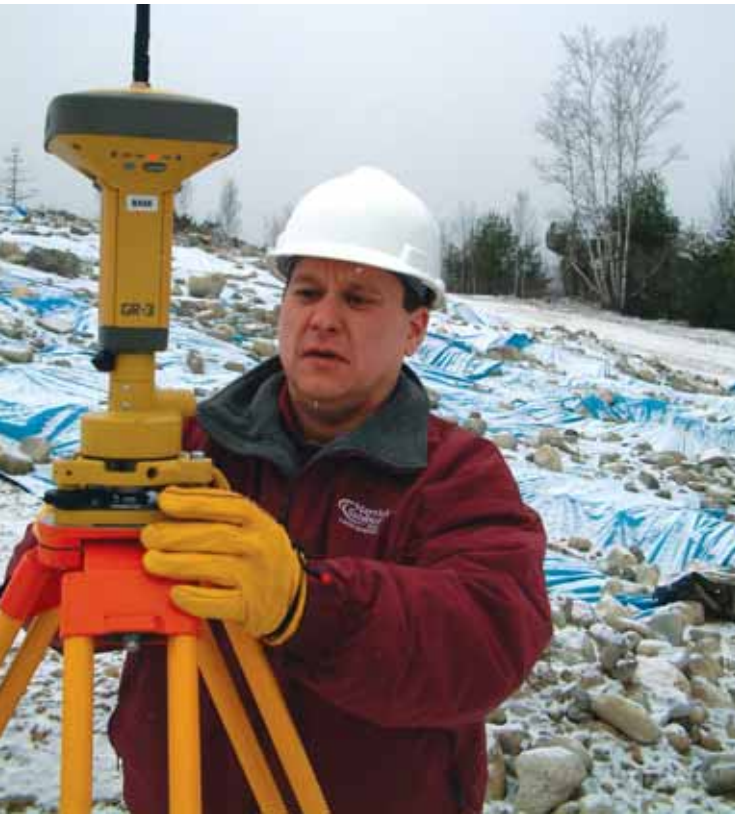
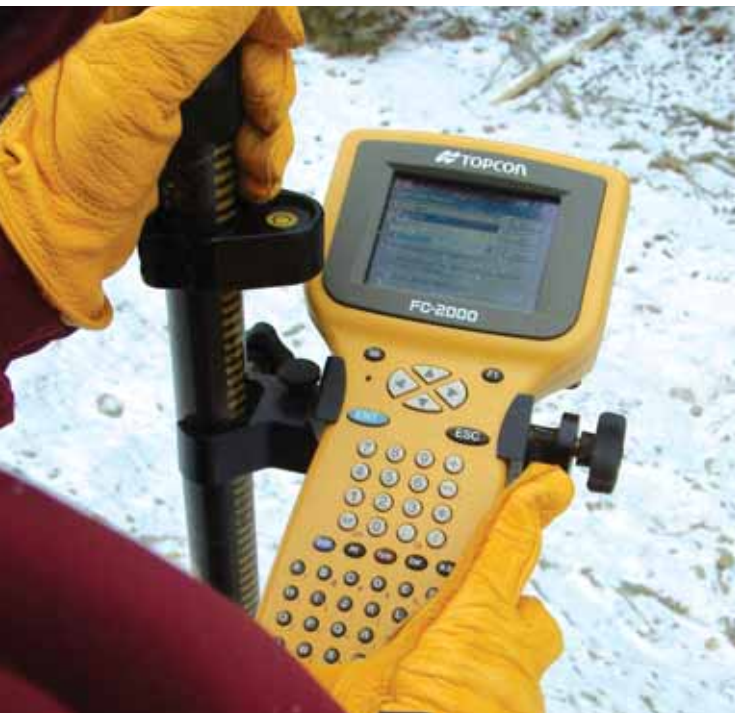
The remediation project included building a new dike

Steve Salsbury of Herrick & Salsbury sets up and uses the Topcon GR-3 RTK GNSS system and the FCS data collector

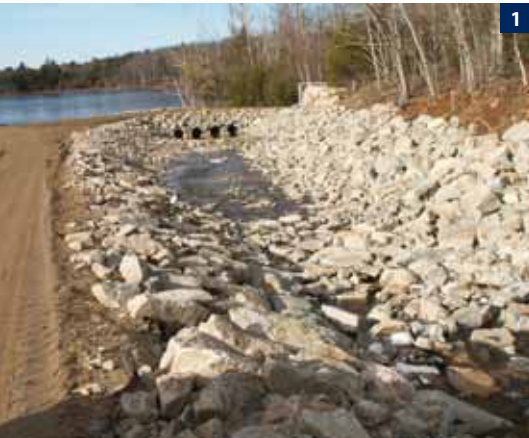
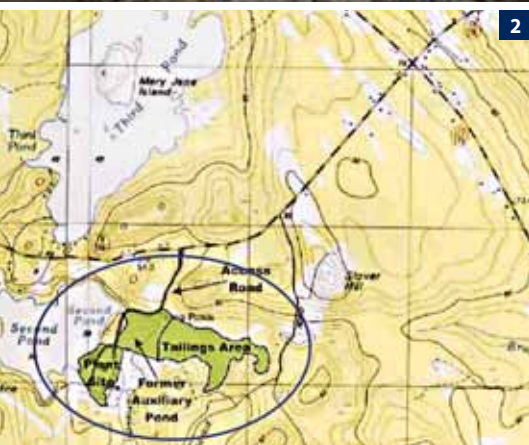
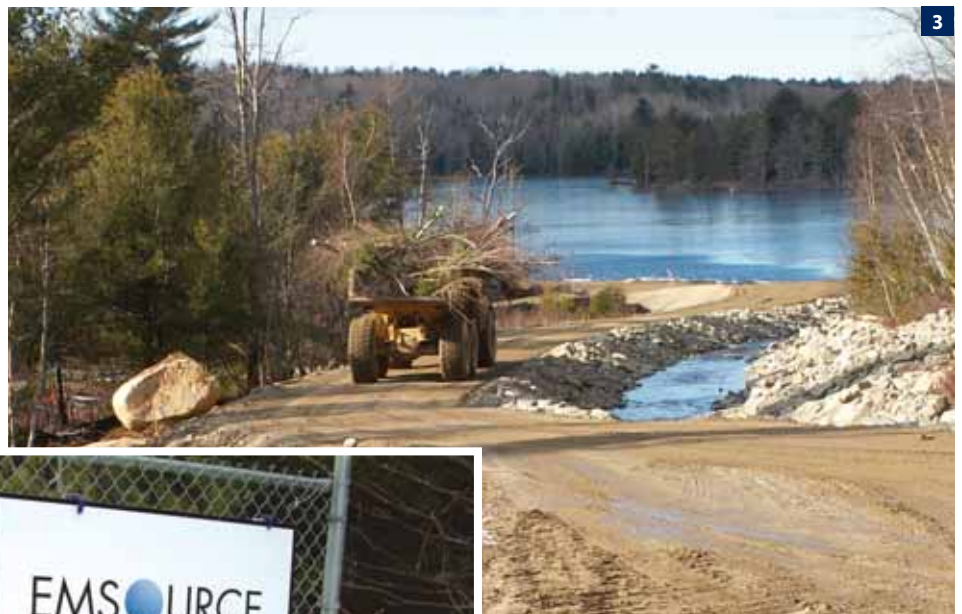
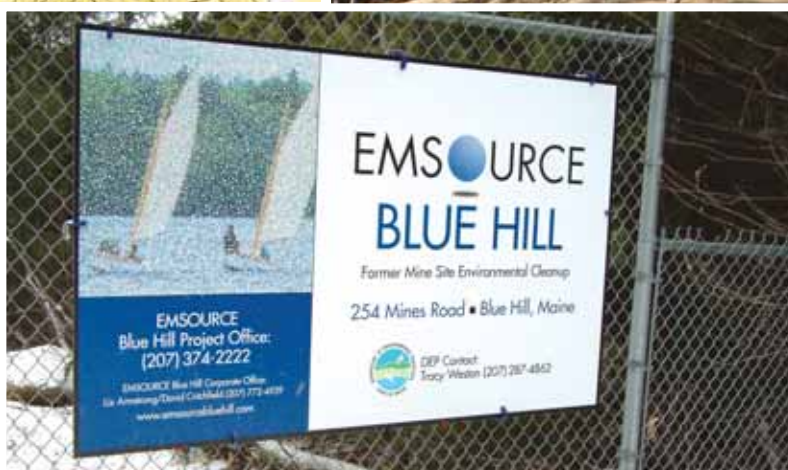
1. View of new ditch going into Second Pond
2. Map of the project area
3. View of new ditch going into Second Pond
