Undoing Past Sins

A long-term surveying project at a mine reclamation job in Maine shows how using multiple satellite positioning constellations can improve productivity.

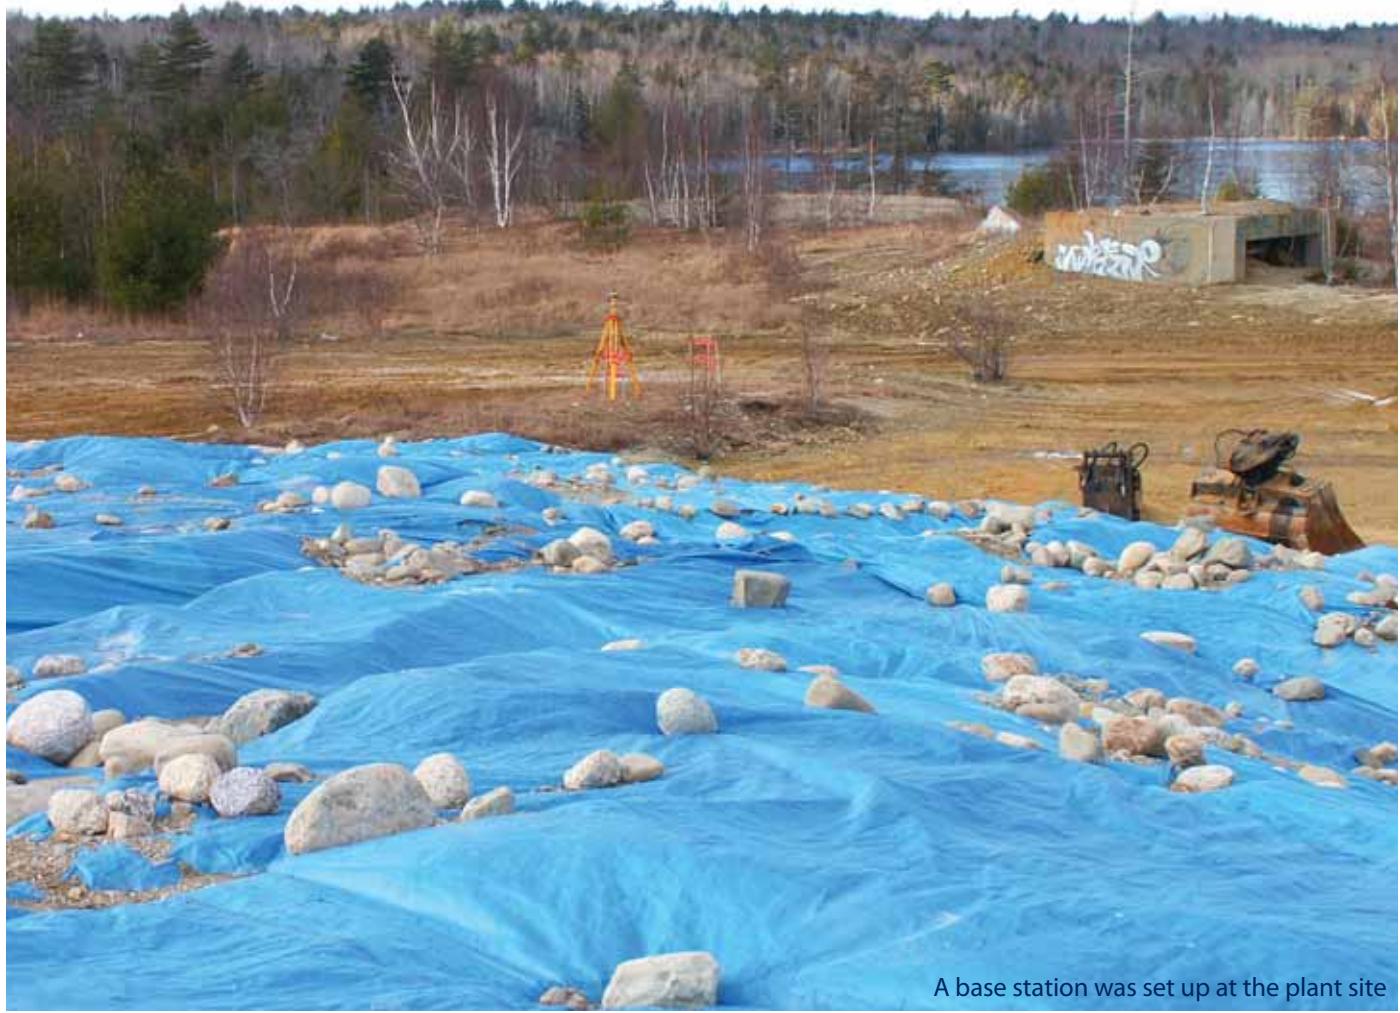
A base station was set up at the plant site

The only unusual aspect of this part of the assignment is the need to keep a detailed log covering everything done over the two-year course of the project. These activities are also complicated by the fact that the site is getting a major facelift, which makes keeping accurate survey control more difficult. "Because the GR-3 base station can be set up virtually anywhere, even a half mile away from

the site," Salsbury says, "we can extend our control well outside the project limits. We have several convenient control points scattered around the site, so we can quickly set up and get to work. The site is hilly with scattered trees plus trucks and earthmoving equipment to interrupt conventional lines of sight, but with the GR-3 RTK, we don't need to maintain line of sight."

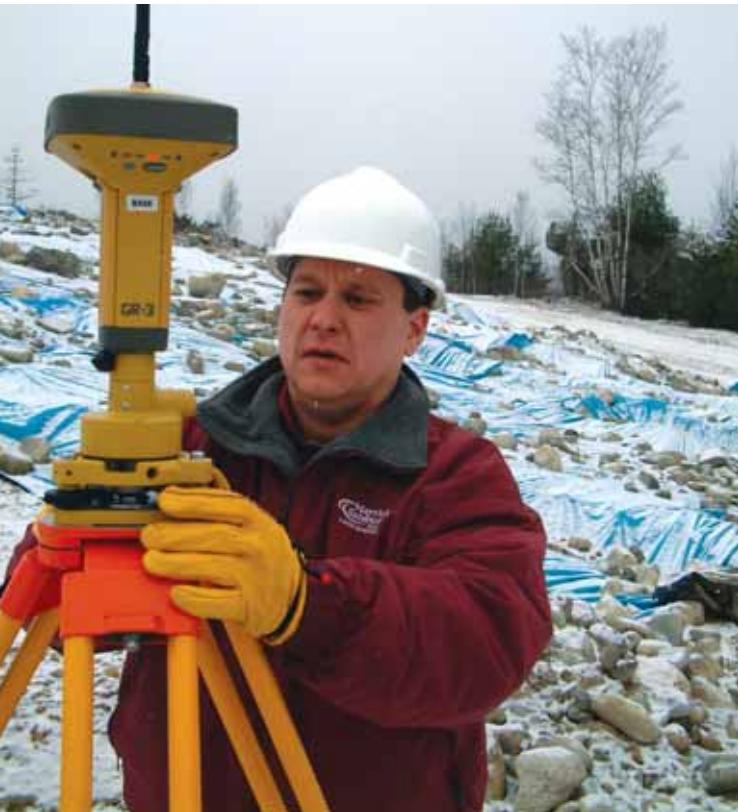
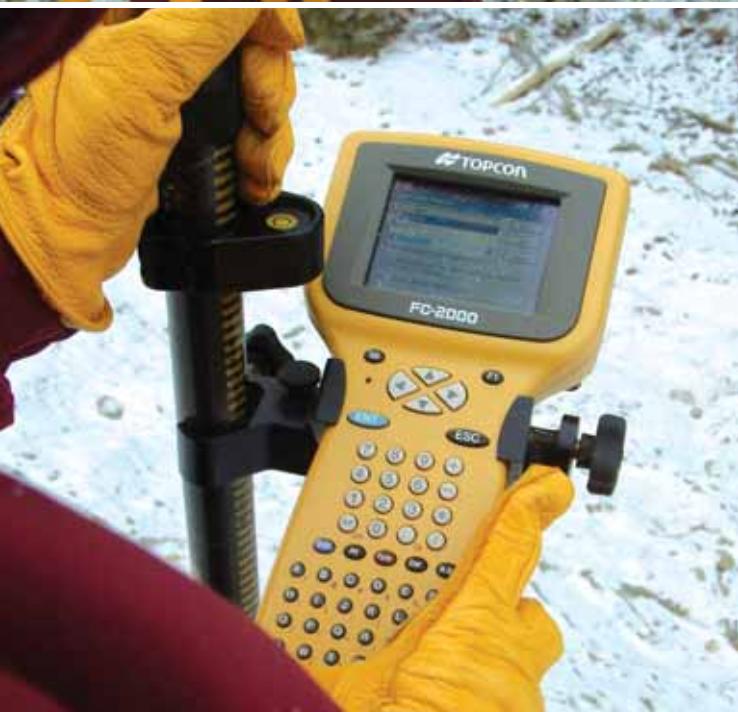
Steve Salsbury of Herrick & Salsbury sets up and uses the Topcon GR-3 RTK GNSS system and the FCS data collector

They owned two single-frequency, L1 static/GIS/GPS mapping grade systems but were looking to upgrade. "We approached the selection task very systematically, evaluating RTK survey-grade systems from several manufacturers in the most realistic field trials we could put together," Salsbury explains. They bought the Topcon GR-3 RTK and used it for the first time on the Blue Hill job.

The Topcon GR-3 RTK can use GPS and GLONASS and can also pick up the European Galileo system test signals. The ability to receive more signals guarantees additional uptime in the field. Equipped with Topcon's new G3 chip technology, the system already incorporates all the planned signal modernization of the GPS and GLONASS satellite systems, enabling it to track all satellite positioning signals now available and all those planned for the future.

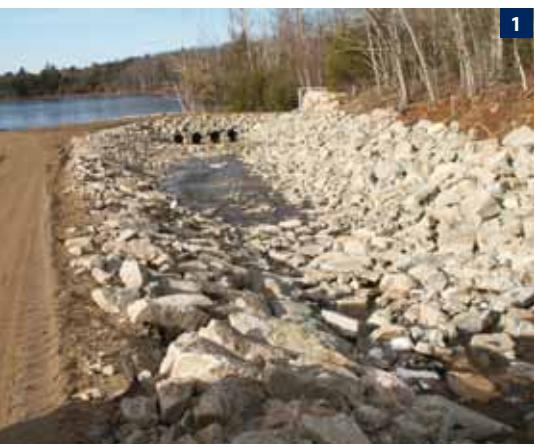
1. View of new ditch going into Second Pond

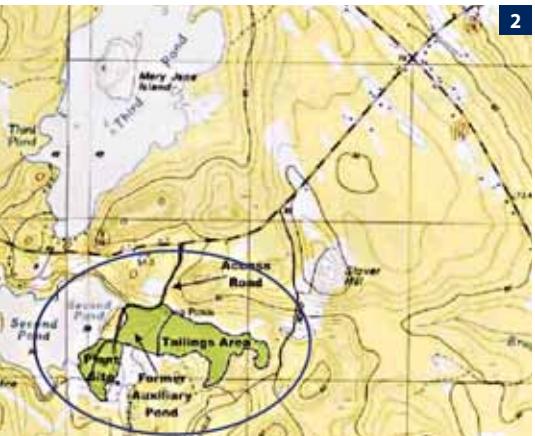
2. Map of the project area

Located along Route 15/176 in Hancock County, Maine, the site includes a 53-acre waste disposal area containing former primary and auxiliary tailings ponds that have been covered with till and vegetation plus a mill process area with a hoist house, service and concentrator buildings, foundations of former thickener units, and the mine shaft head frame. Three unnamed intermittent streams and Carlton Stream flow through the property, which is bordered by Second Pond to the west, Carlton Stream to the south, and undeveloped land to the east and north.

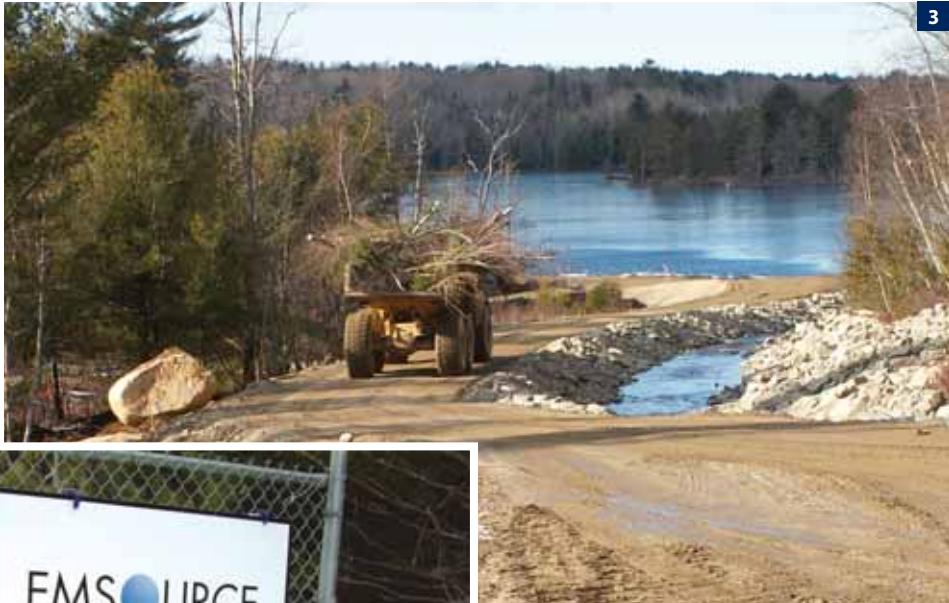
3. View of new ditch going into Second Pond
